LAKE ALTOONA DAM

NDI I.D. NO: 532

PHASE I INSPECTION REPORT
NATIONAL DAM INSPECTION PROGRAM.

SEPTEMBER 1978

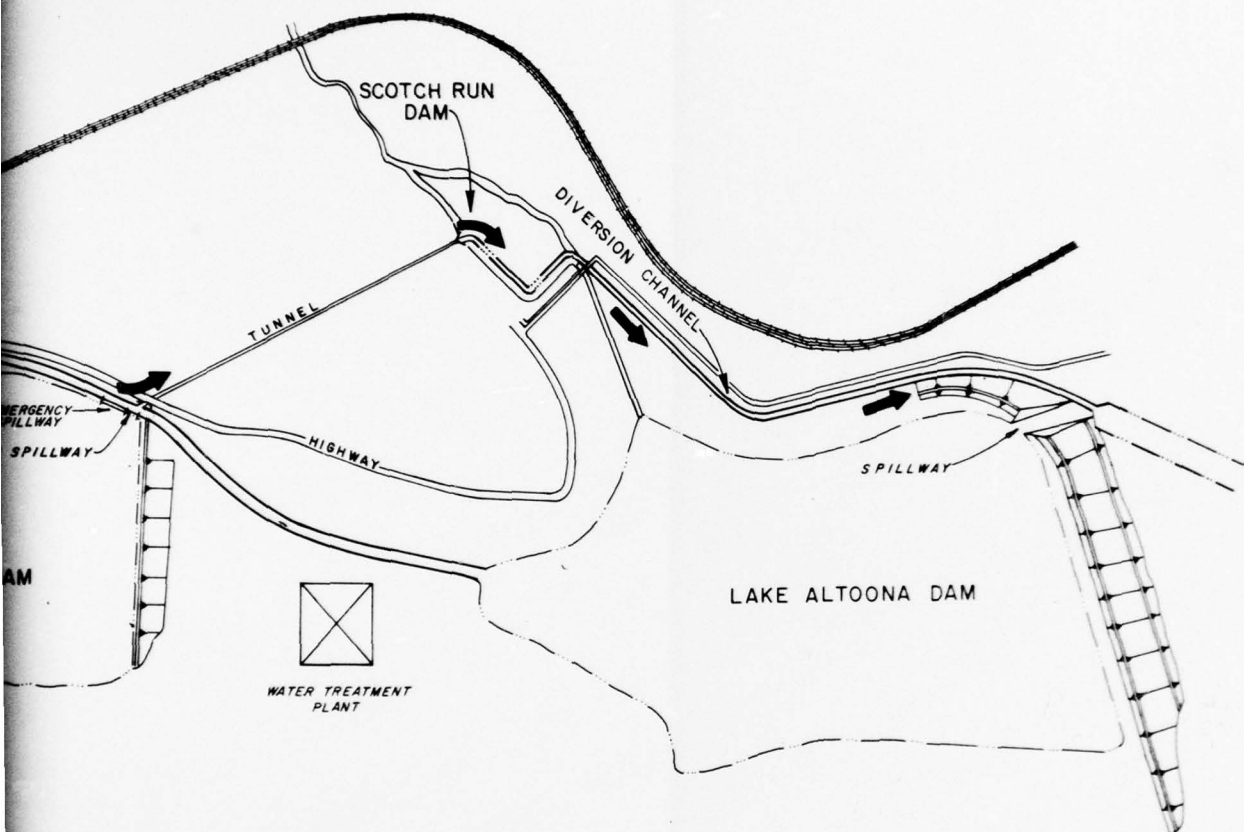
PLATE 2
LAKE ALTOONA DAM
DIVERSION CHANNEL PLAN
D'APPOLONIA

The normal runoff from the Burgoon Run watershed is diverted through a channel bypassing the reservoir (Plate 2). The excess flow into the reservoir is discharged over the spillway into the diversion channel which terminates at a plunge pool at the toe of the dam.

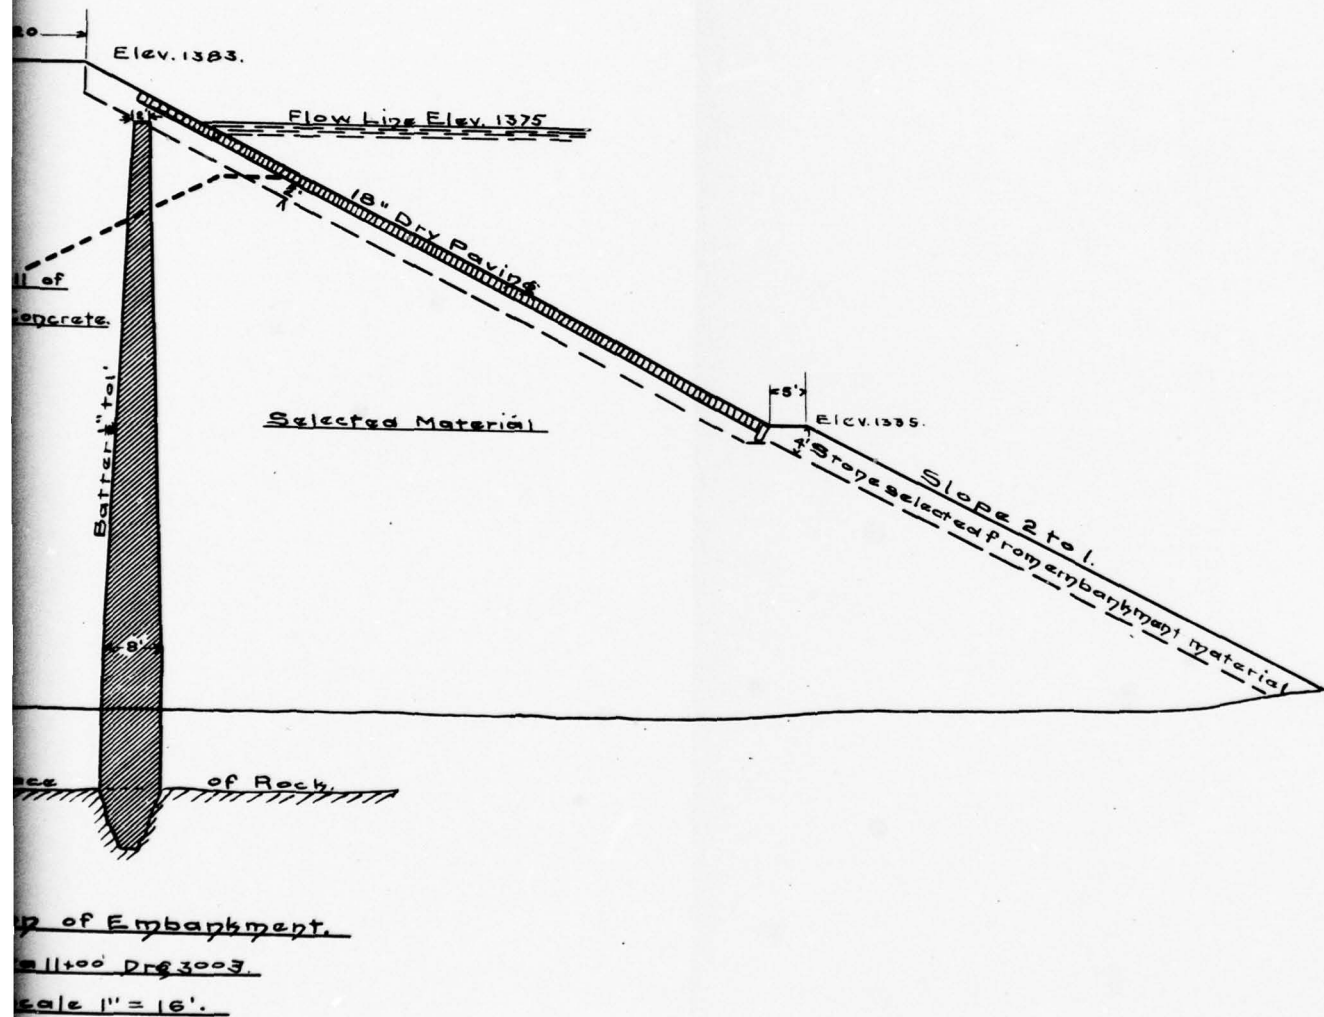
PLATE 3

- a. As designed, the dam was supposed to be a 90-foot-high embankment with its crest at Elevation 1383 (Plate 3). However, the dam was only completed to Elevation 1364.

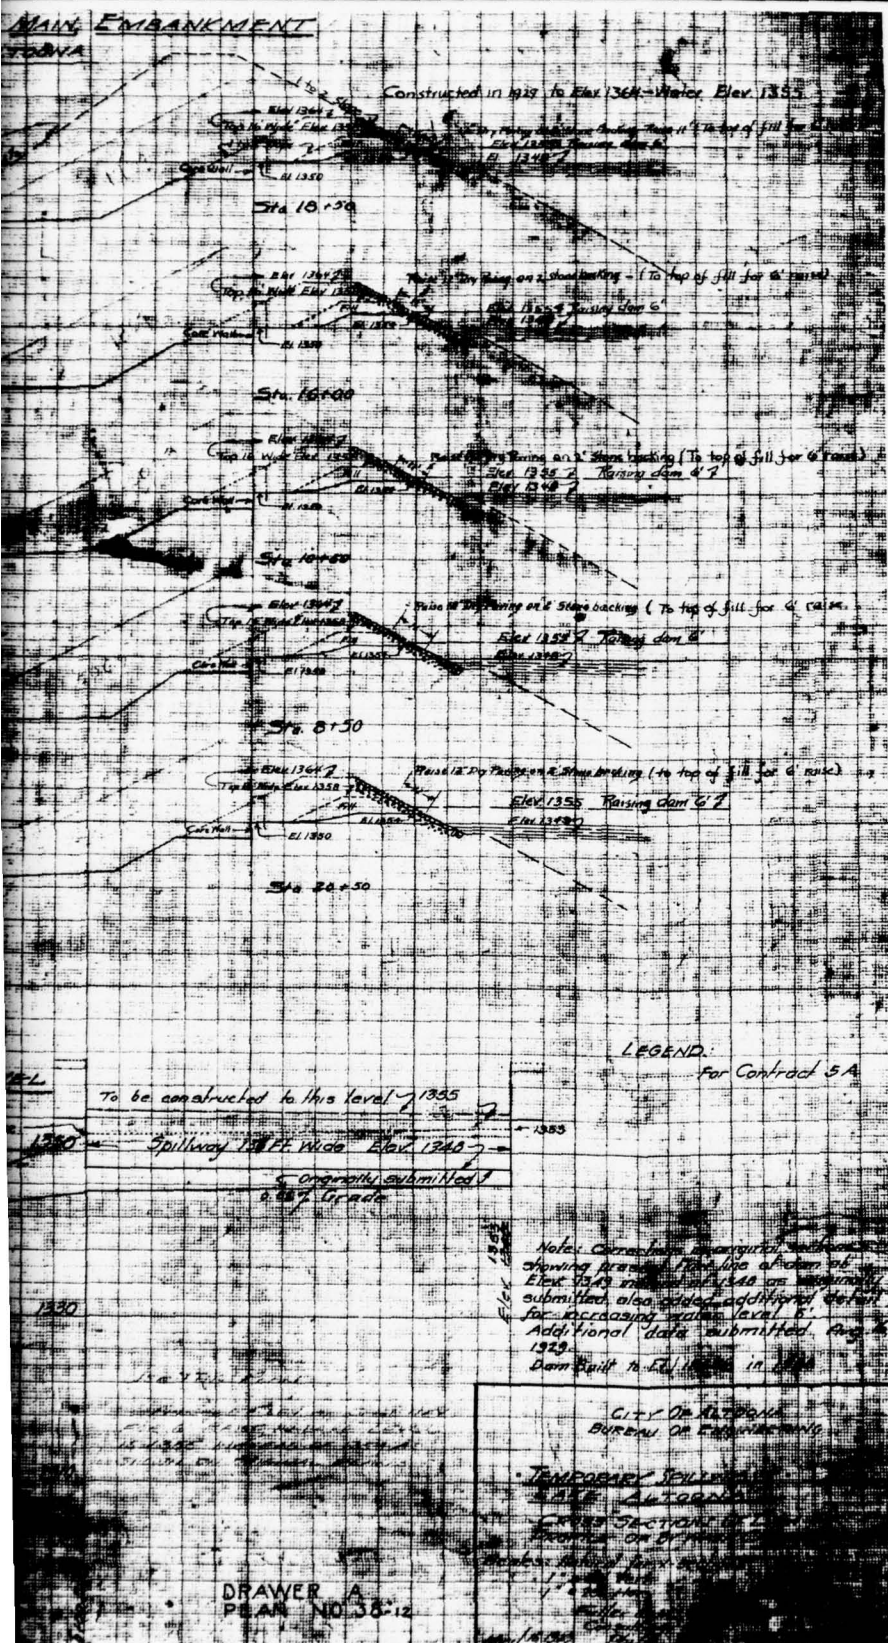
PLATE 5

- c. The embankment, as it exists, has two to one (horizontal to vertical) slopes on both the downstream and upstream slopes (Plate 5). The downstream slope of the dam is broken by two benches: a 40-foot-wide bench 33 feet below the dam, and a 25-foot-wide bench 58 feet below the dam crest.

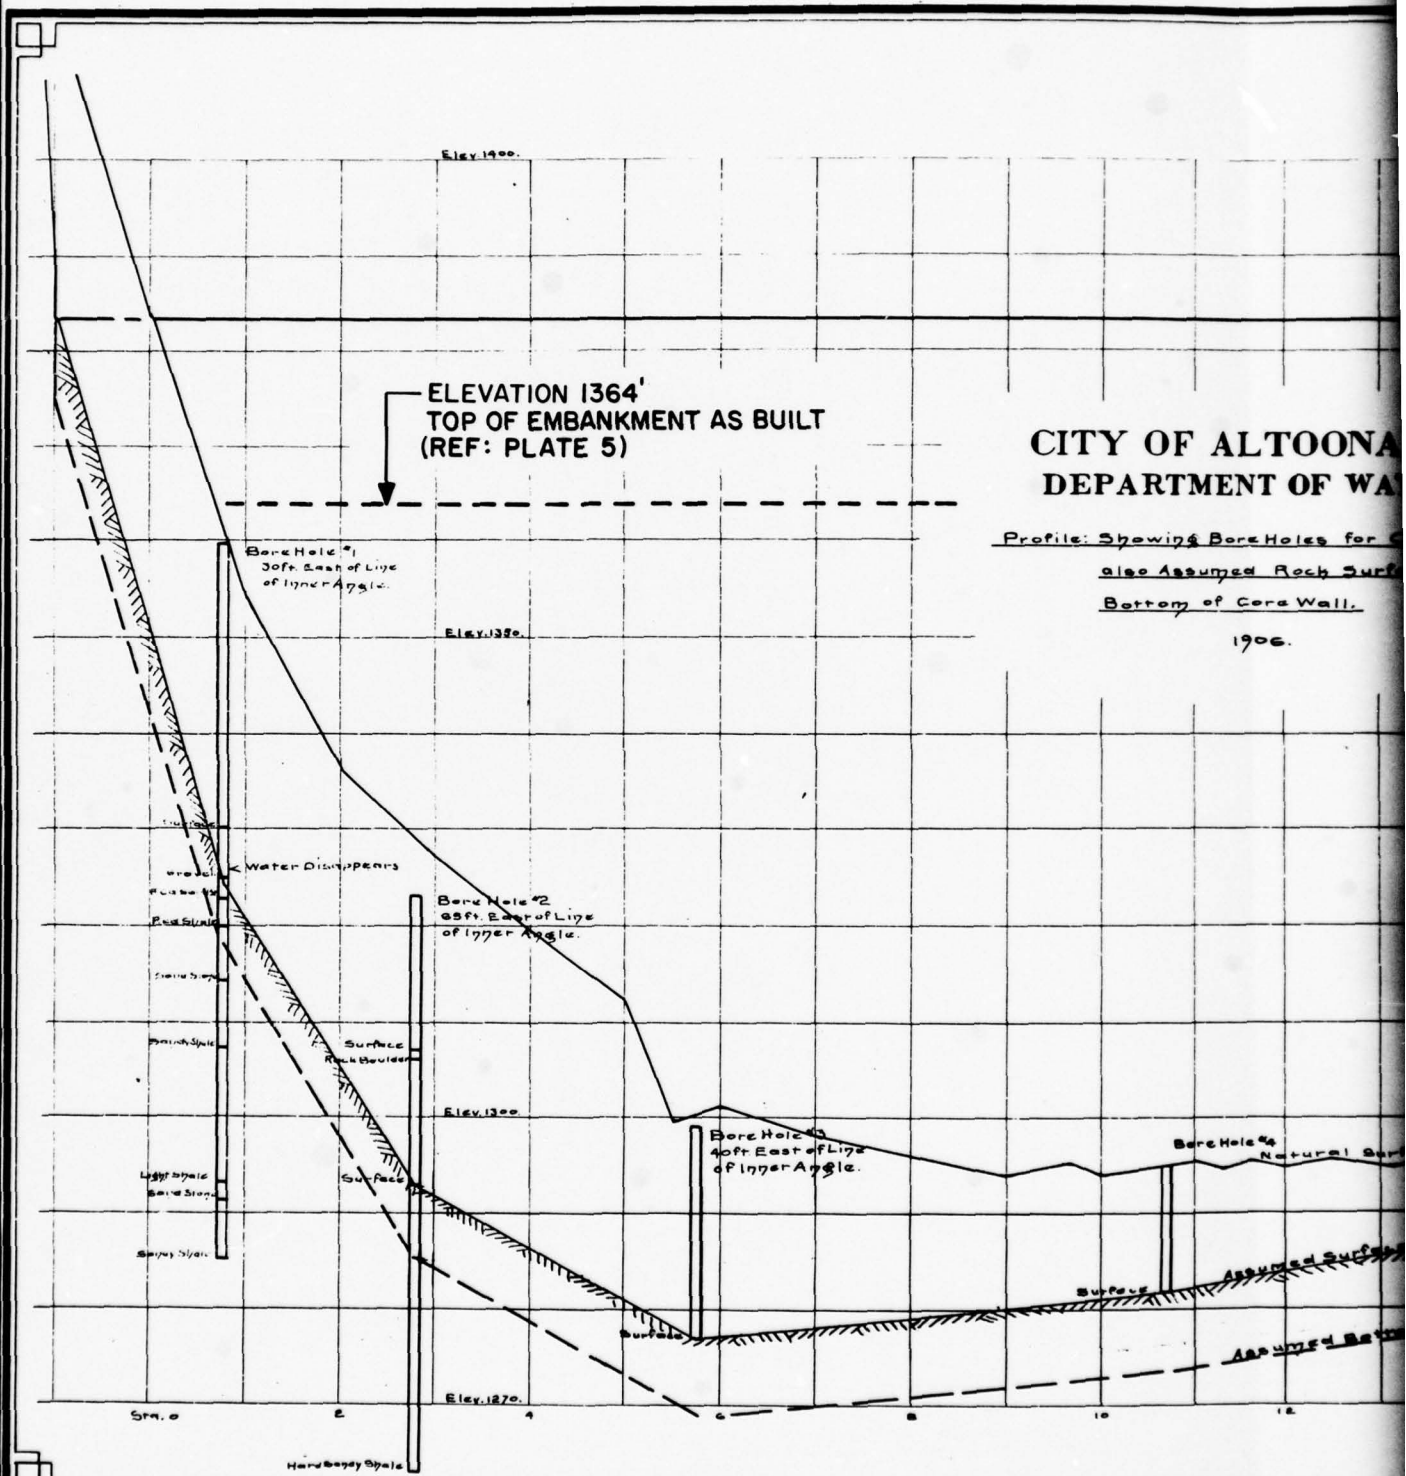
Profile: Showing Bore Holes for
also Assumed Rock Surface
Bottom of Core Wall.
1906.

- d. A design drawing (Plate 6) indicates at least six holes were drilled to investigate the subsurface conditions at the site. The borings indicate that the typical subsurface condition at the site consists of 10 to 30 feet of overburden underlain by alternating layers of

sandstone and shale. The borings were extended from 30 to 70 feet into the foundation rock.
